PERATION

GREENHOUSE

SCIENTIFIC DIRECTOR'S REPORT

ANNEX 3.2 U. S. NAVY STRUCTURES

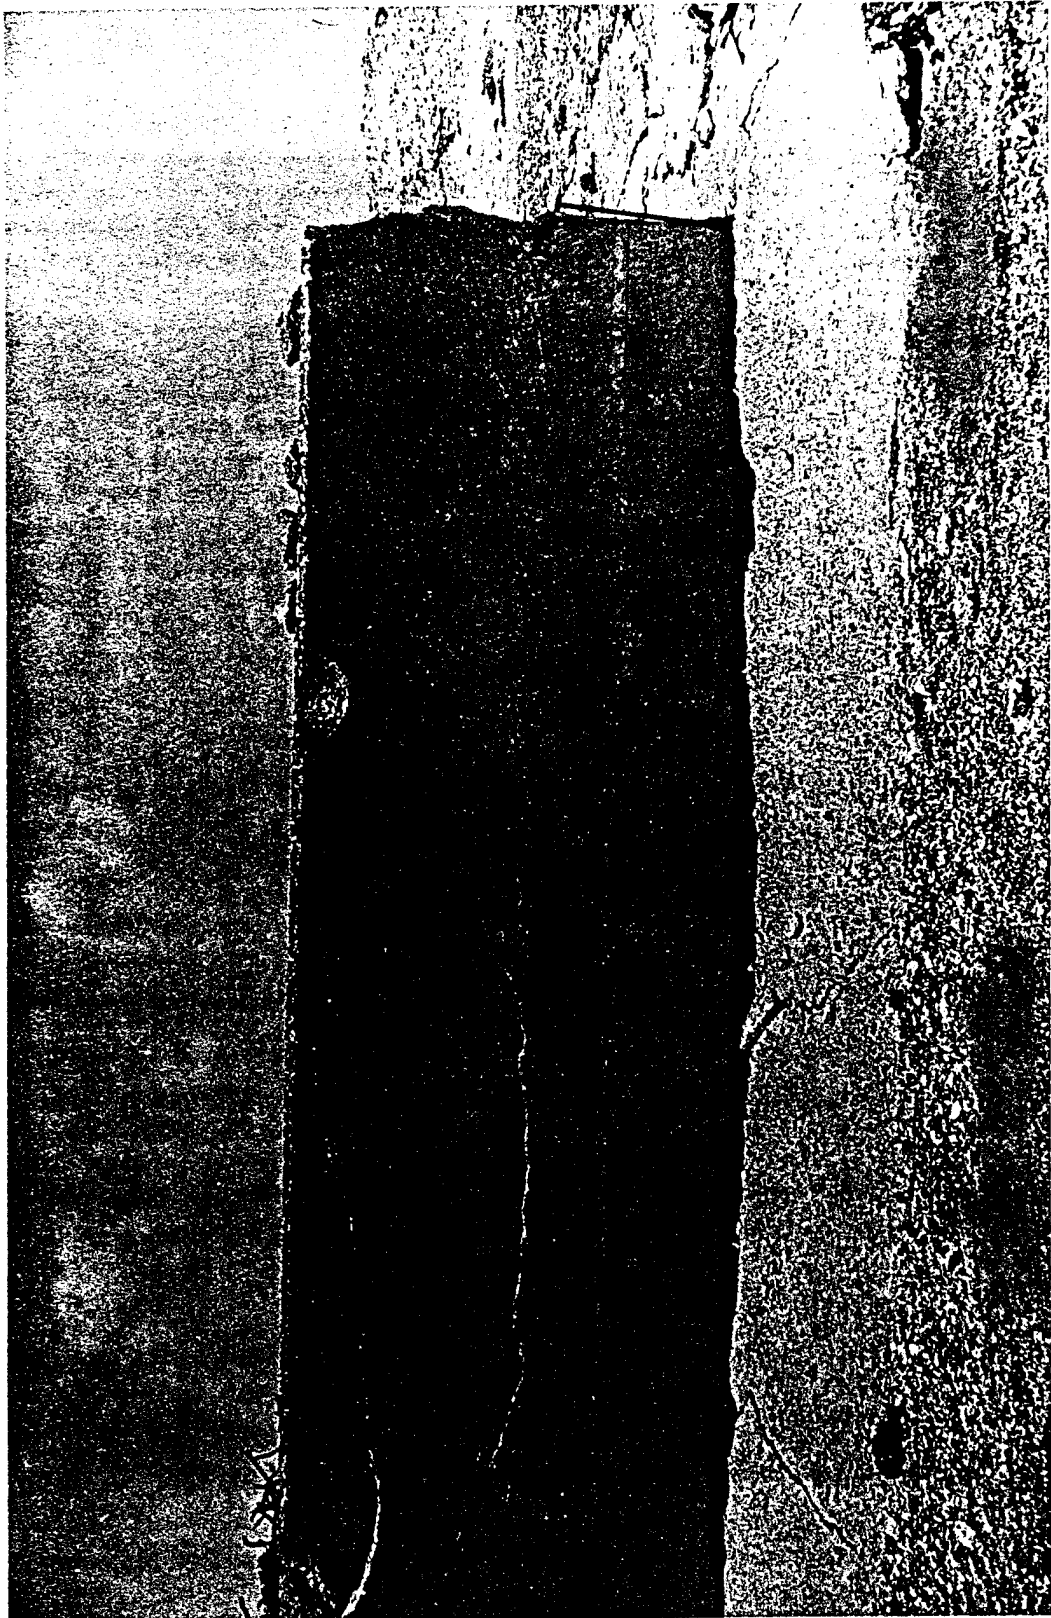
Fig. L.17 Right End of Right Edge of Slab, Structure 3.2.1a

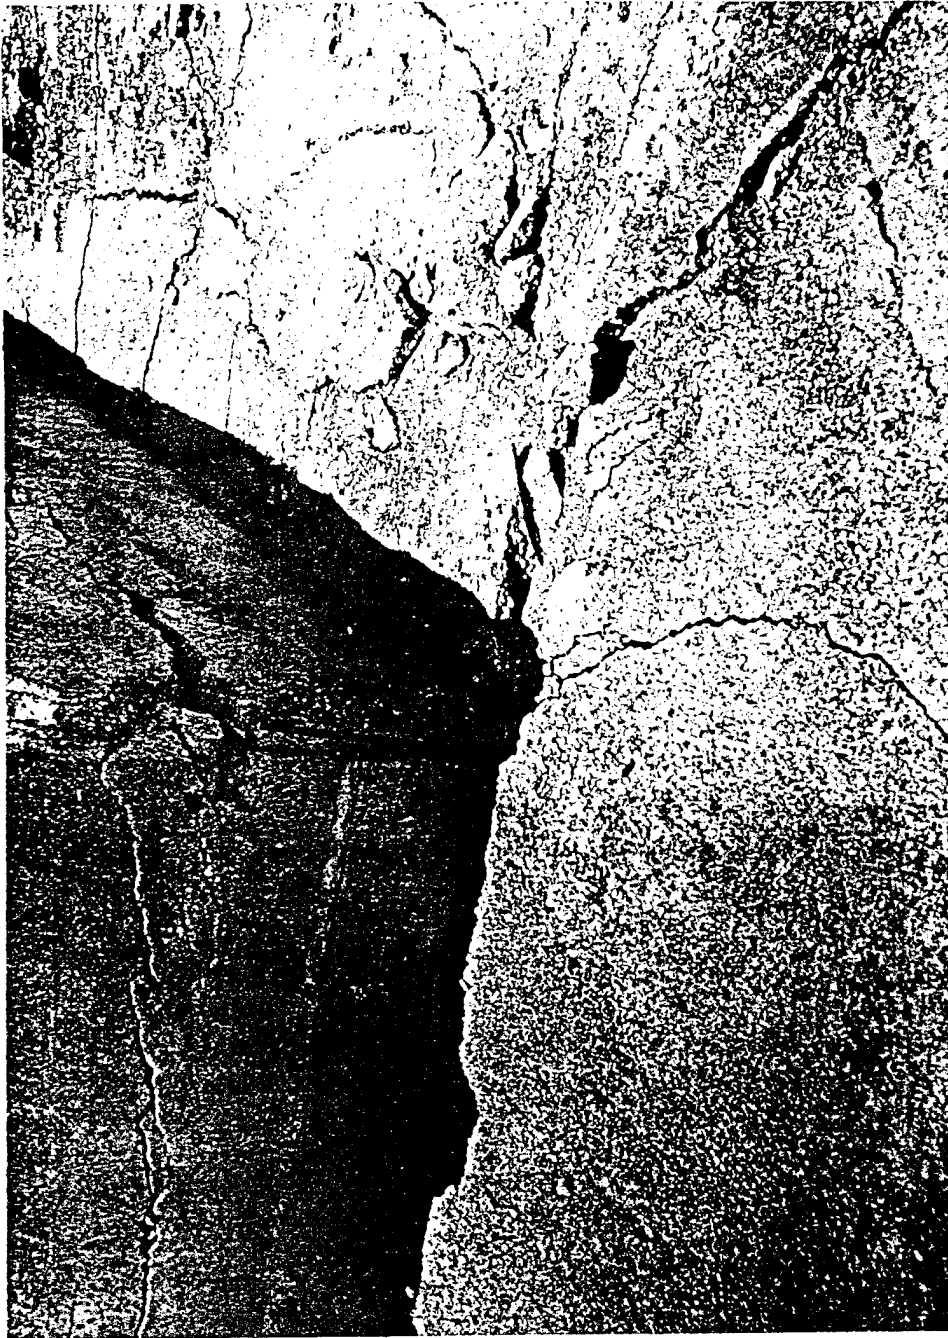
Fig. L.18 Concrete Apron at Right Rear Corner, Structure 3.2.1a

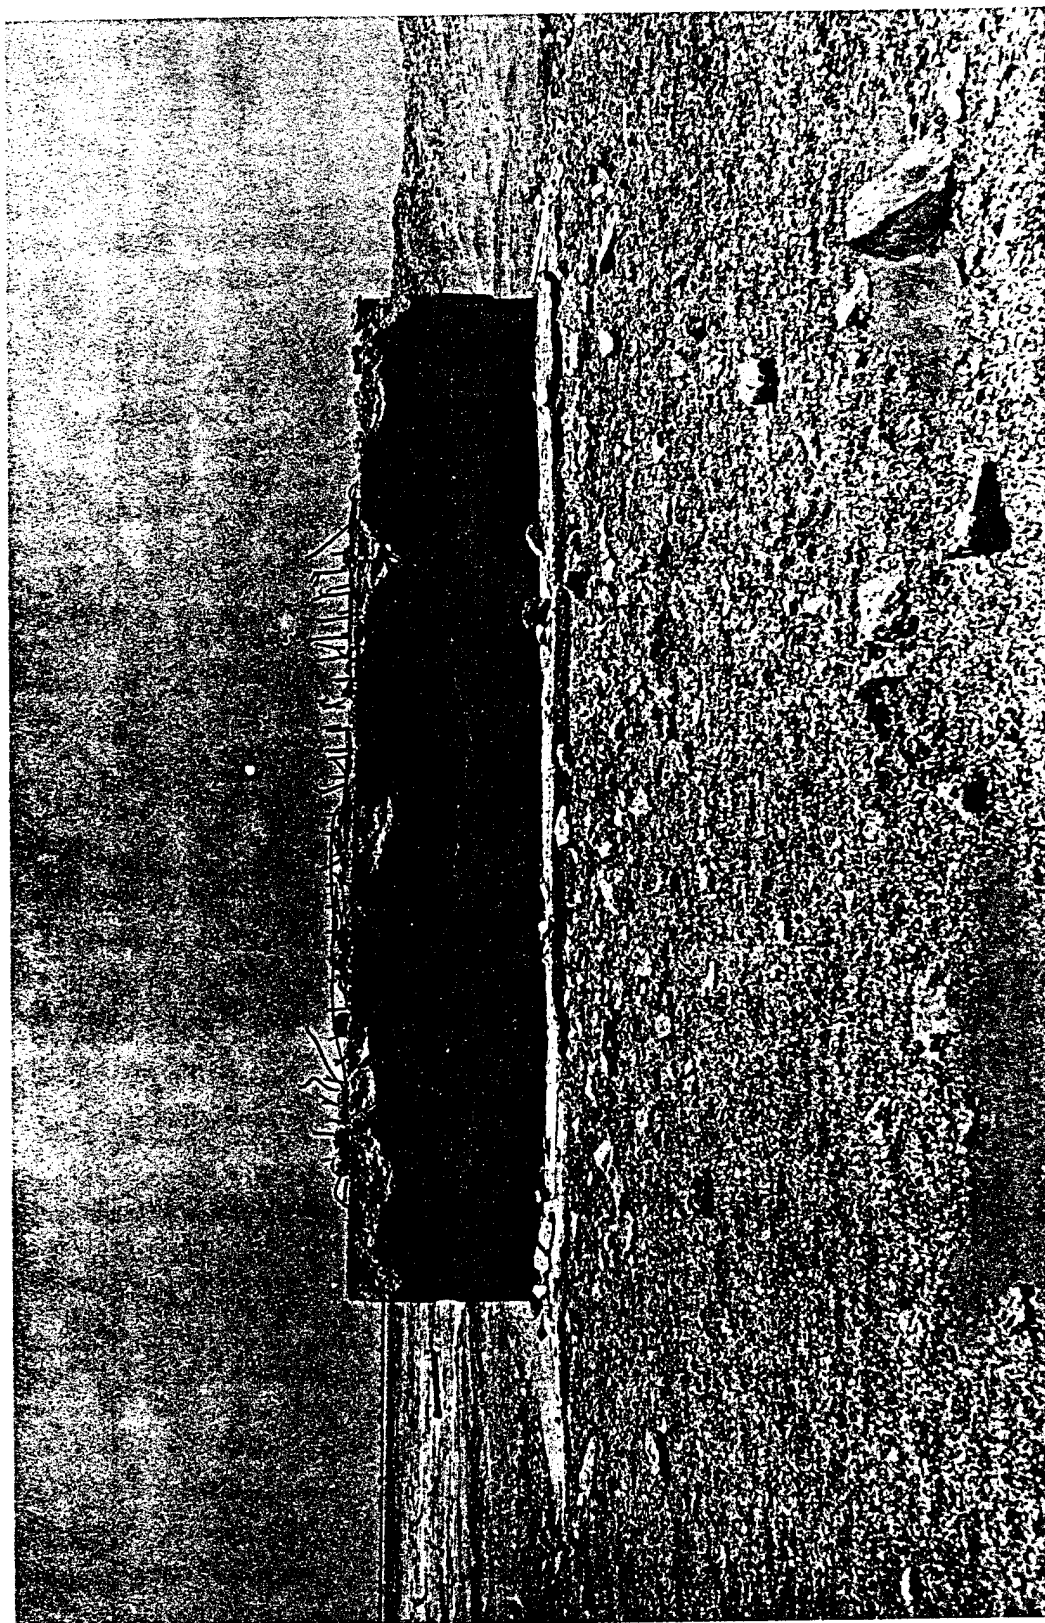
Fig. L.19 General View of Rear Wall, Structure 3.2.1a

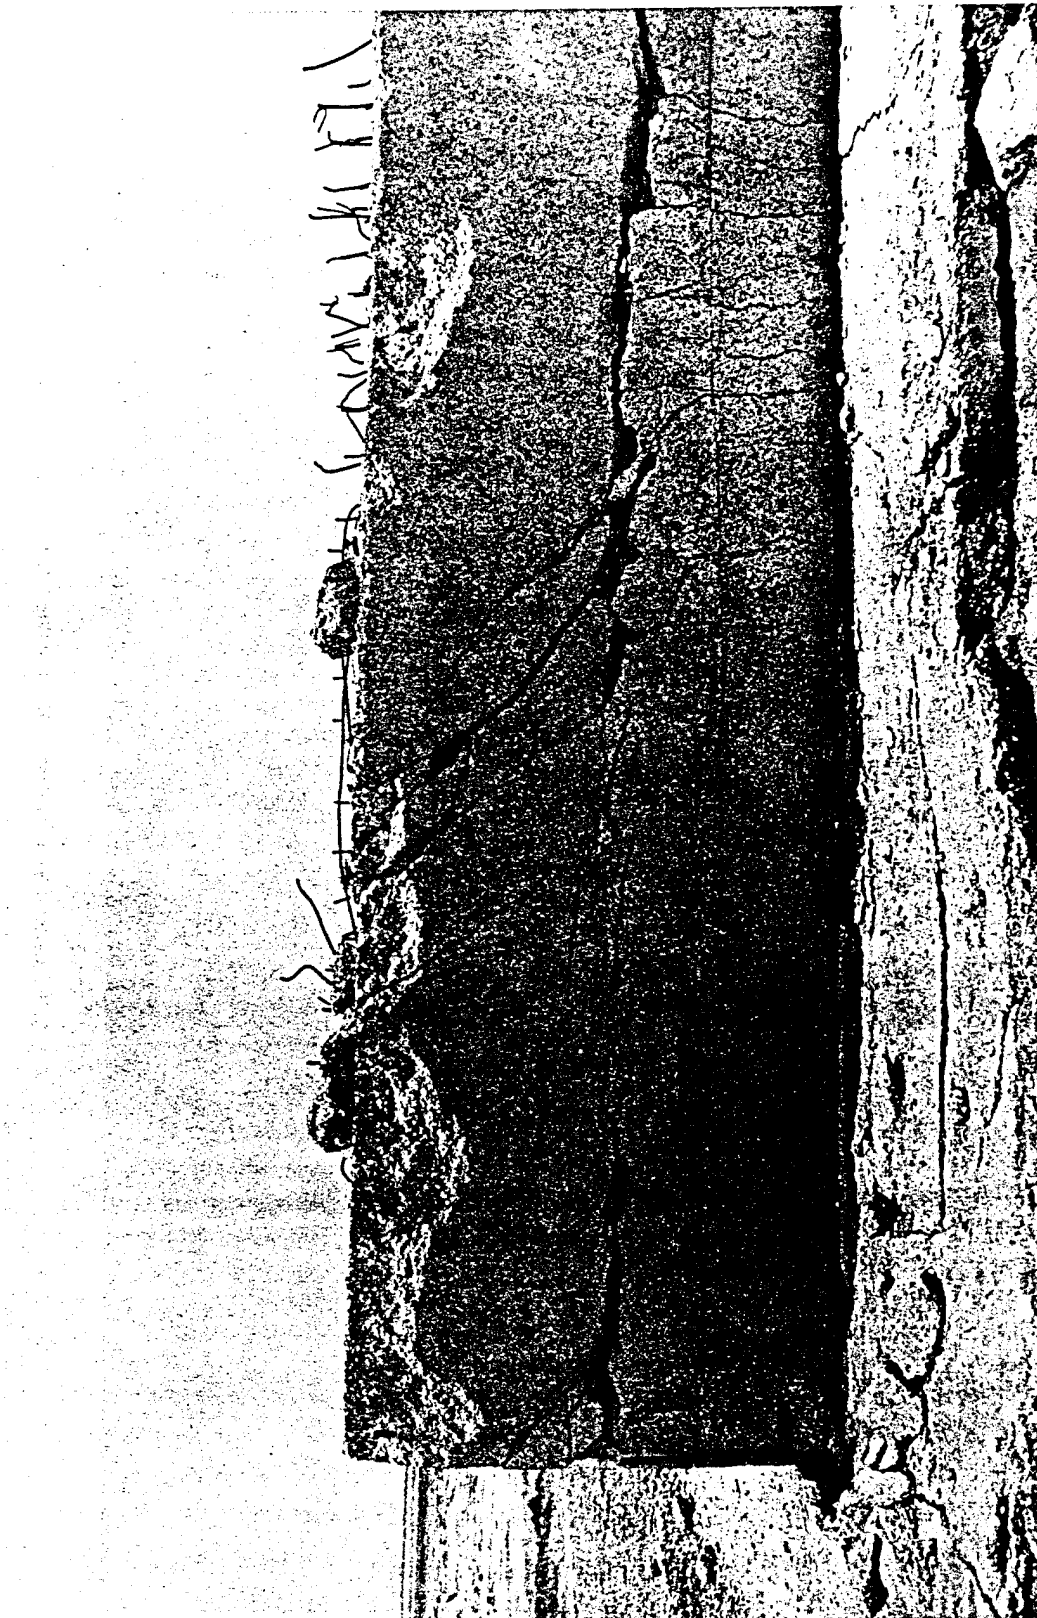
Fig. L.20 Left Half of Rear Wall, Structure 3.2.1a

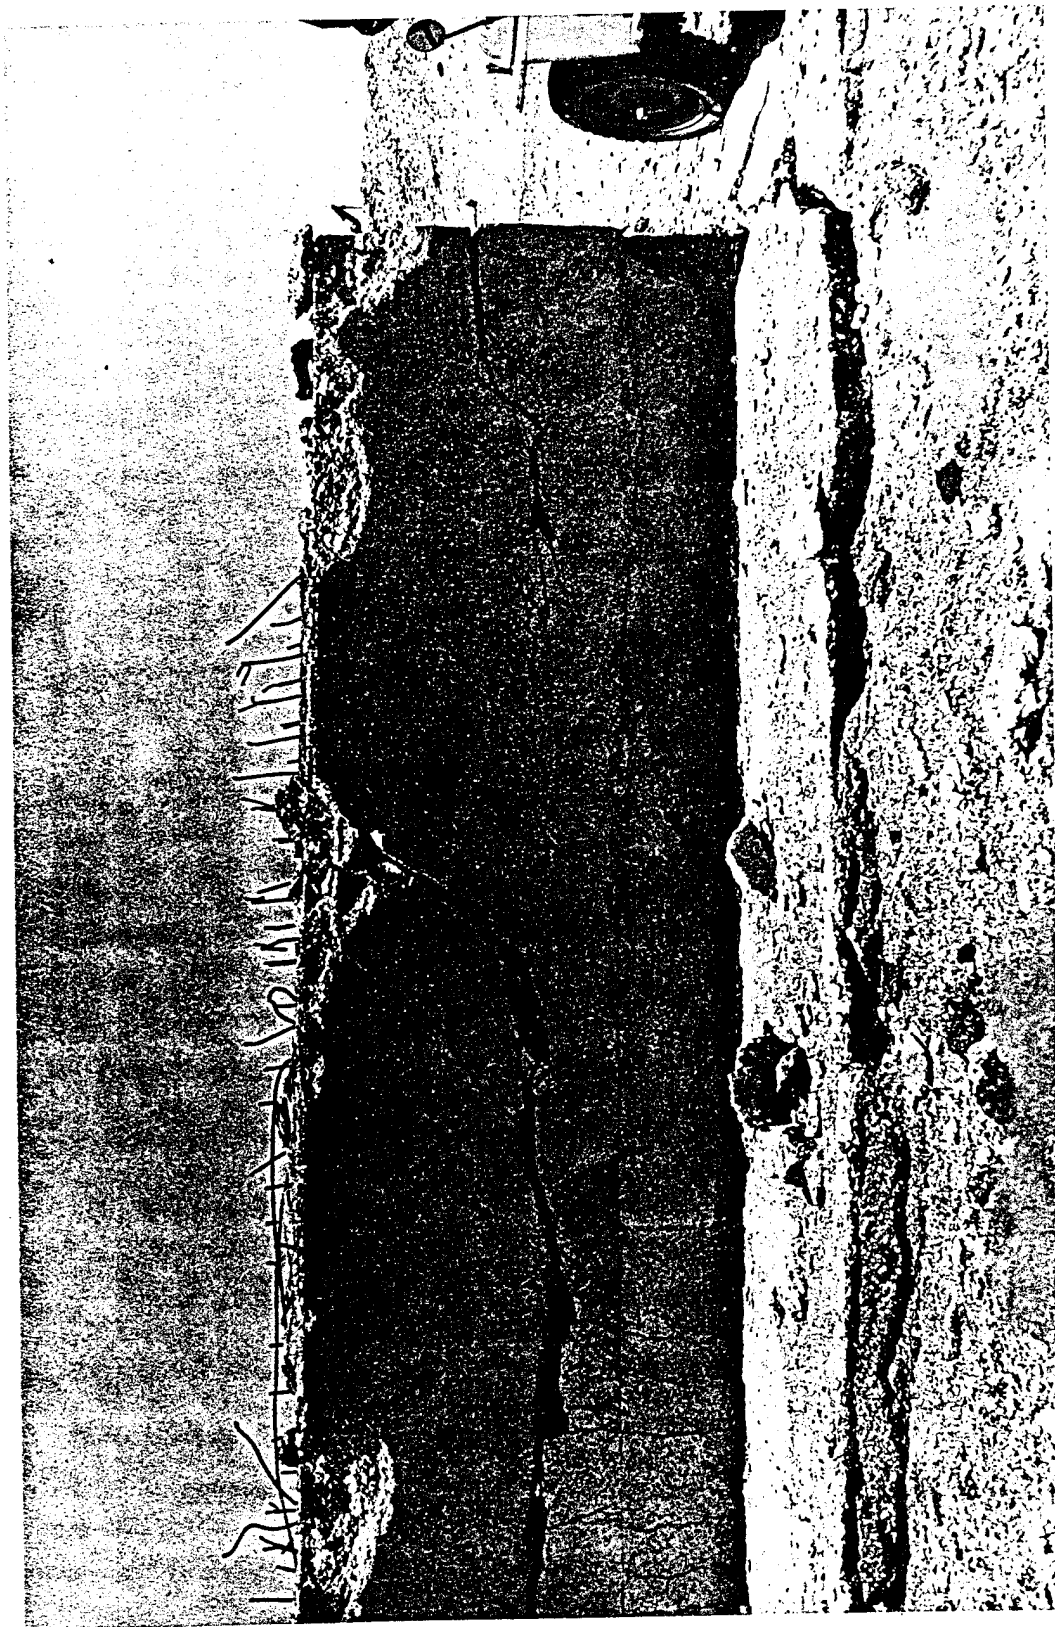
Fig. L.21 Right Half of Rear Wall, Structure 3.2.1a

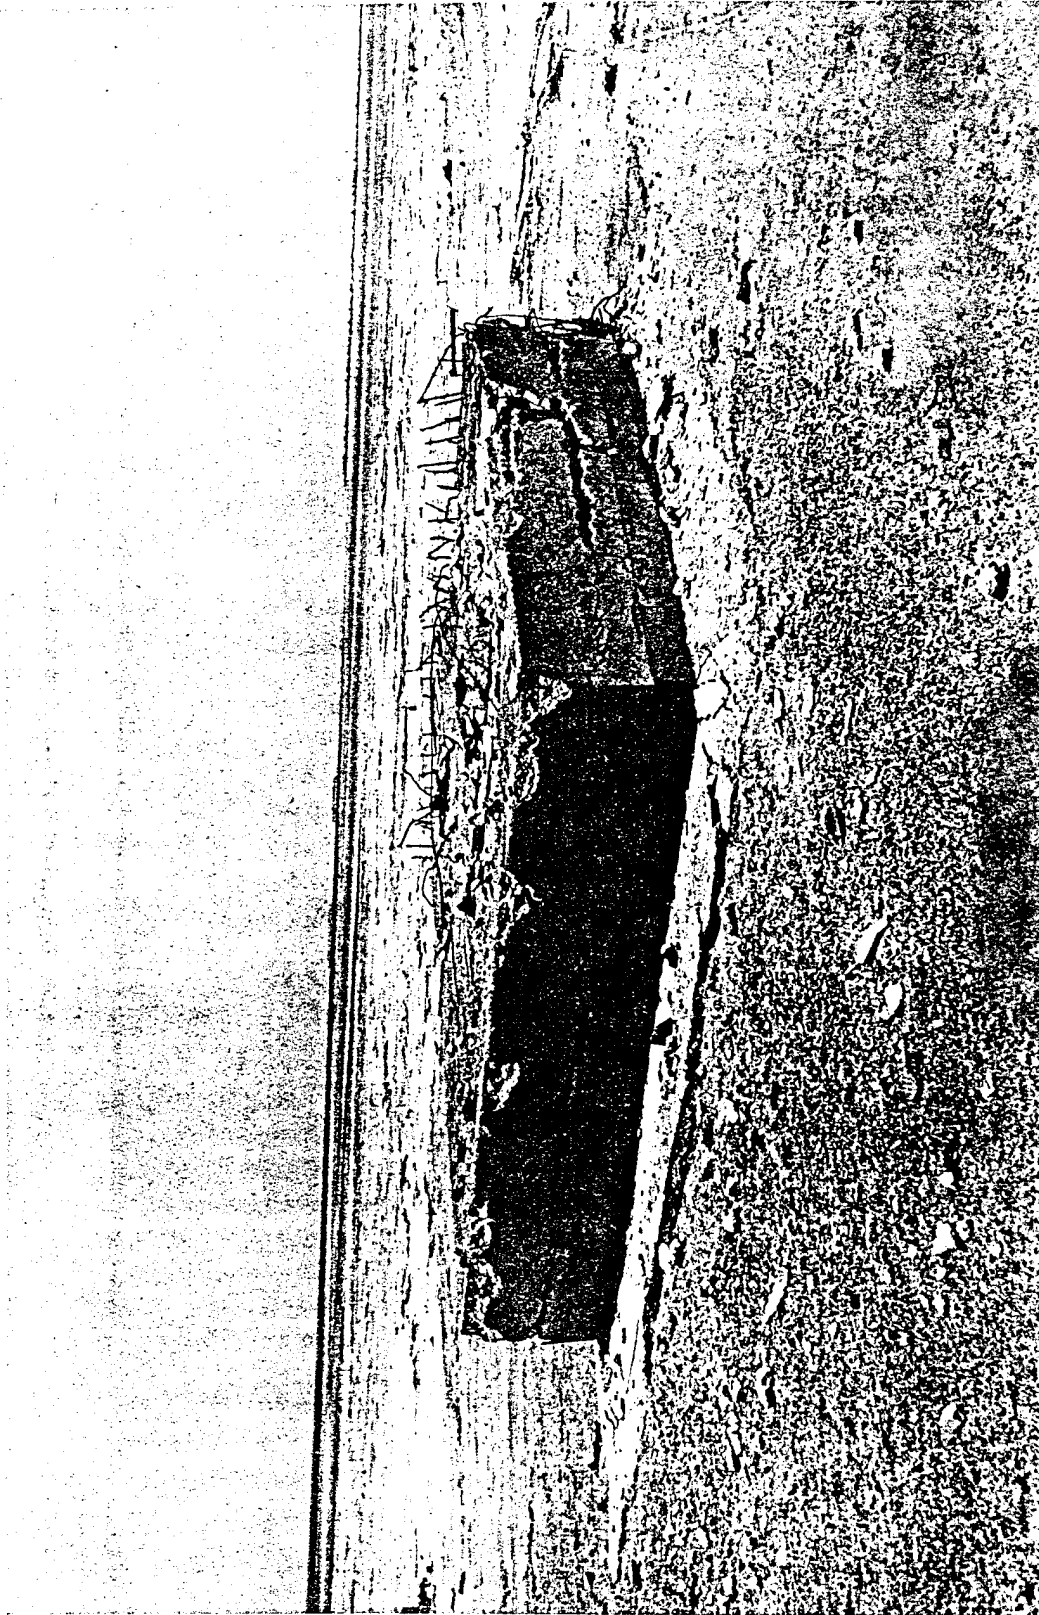
Fig. L.22 General View of Roof from Left Rear, Structure 3.2.1a

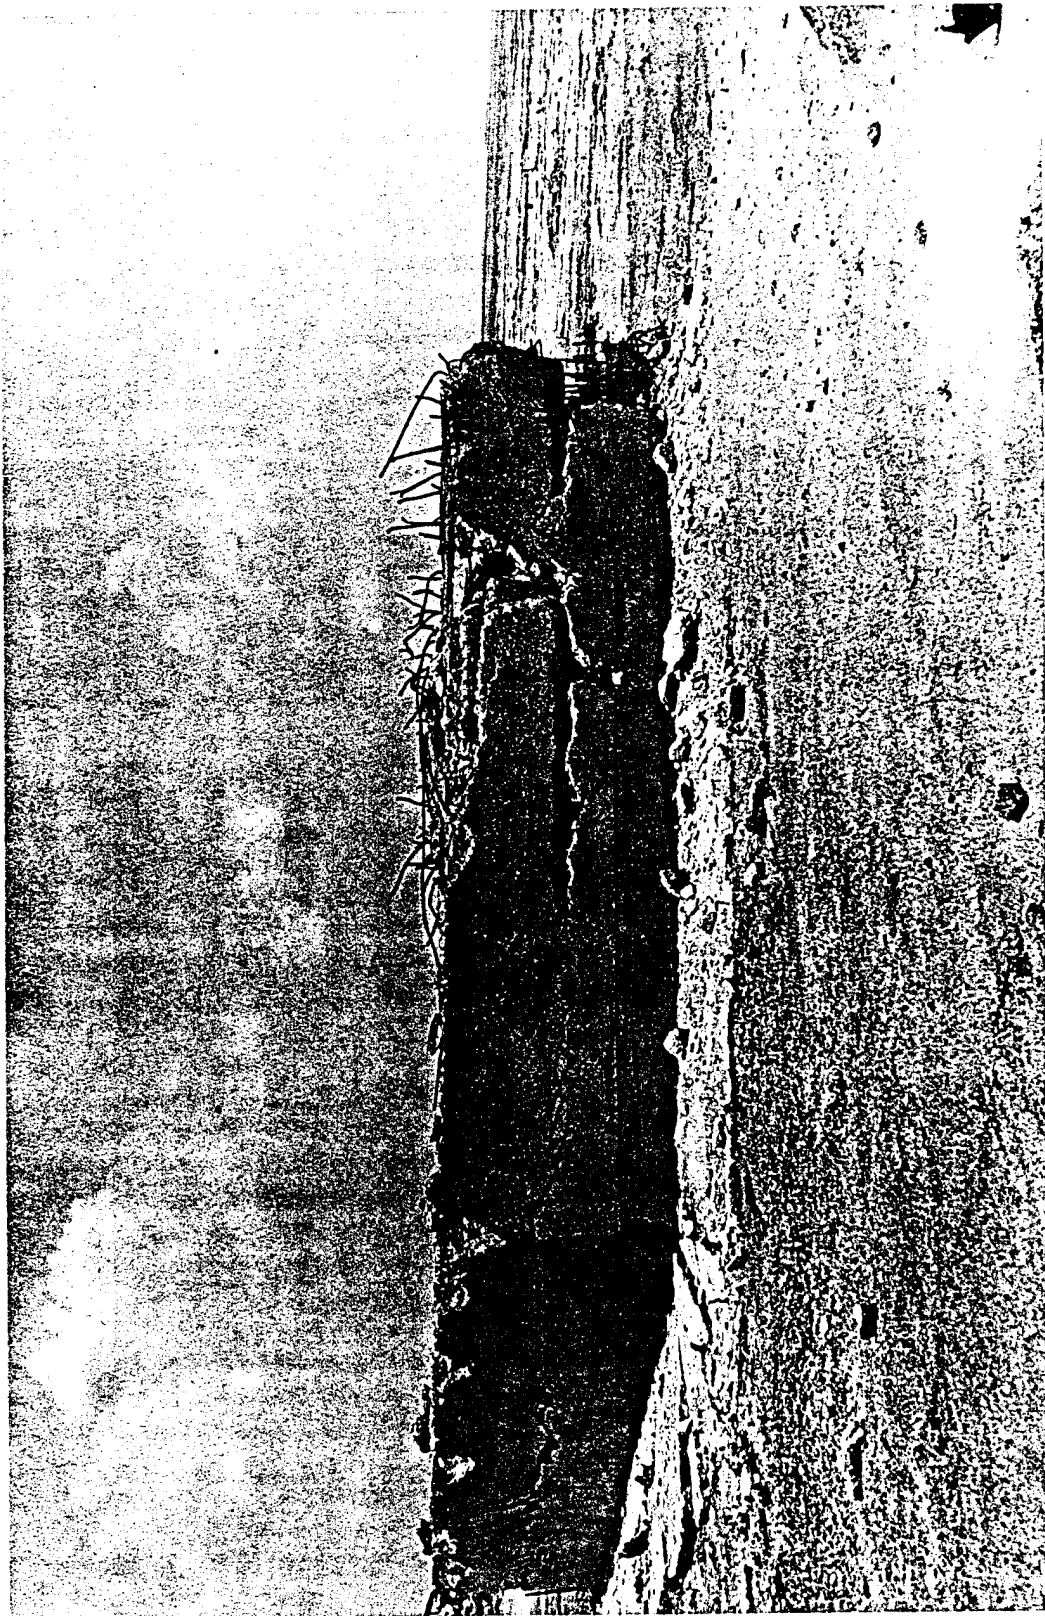
Fig. L.23 General View of Left Side from Left Rear, Structure 3.2.1a

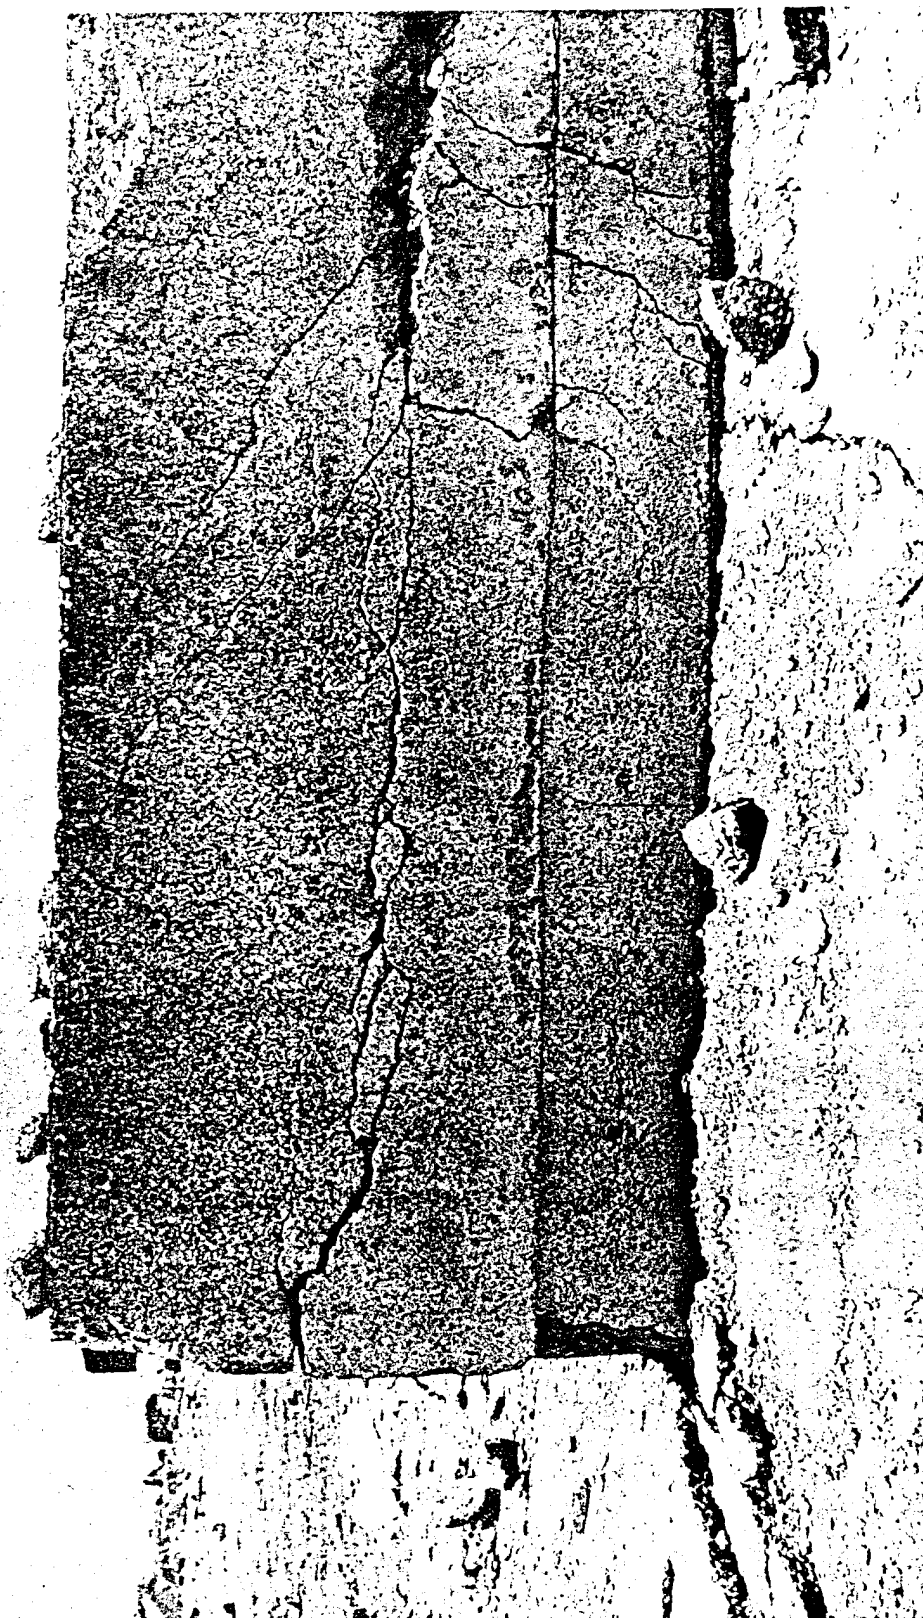
Fig. 1.24 Left Half of Left Side Wall, Structure 3.2.1a

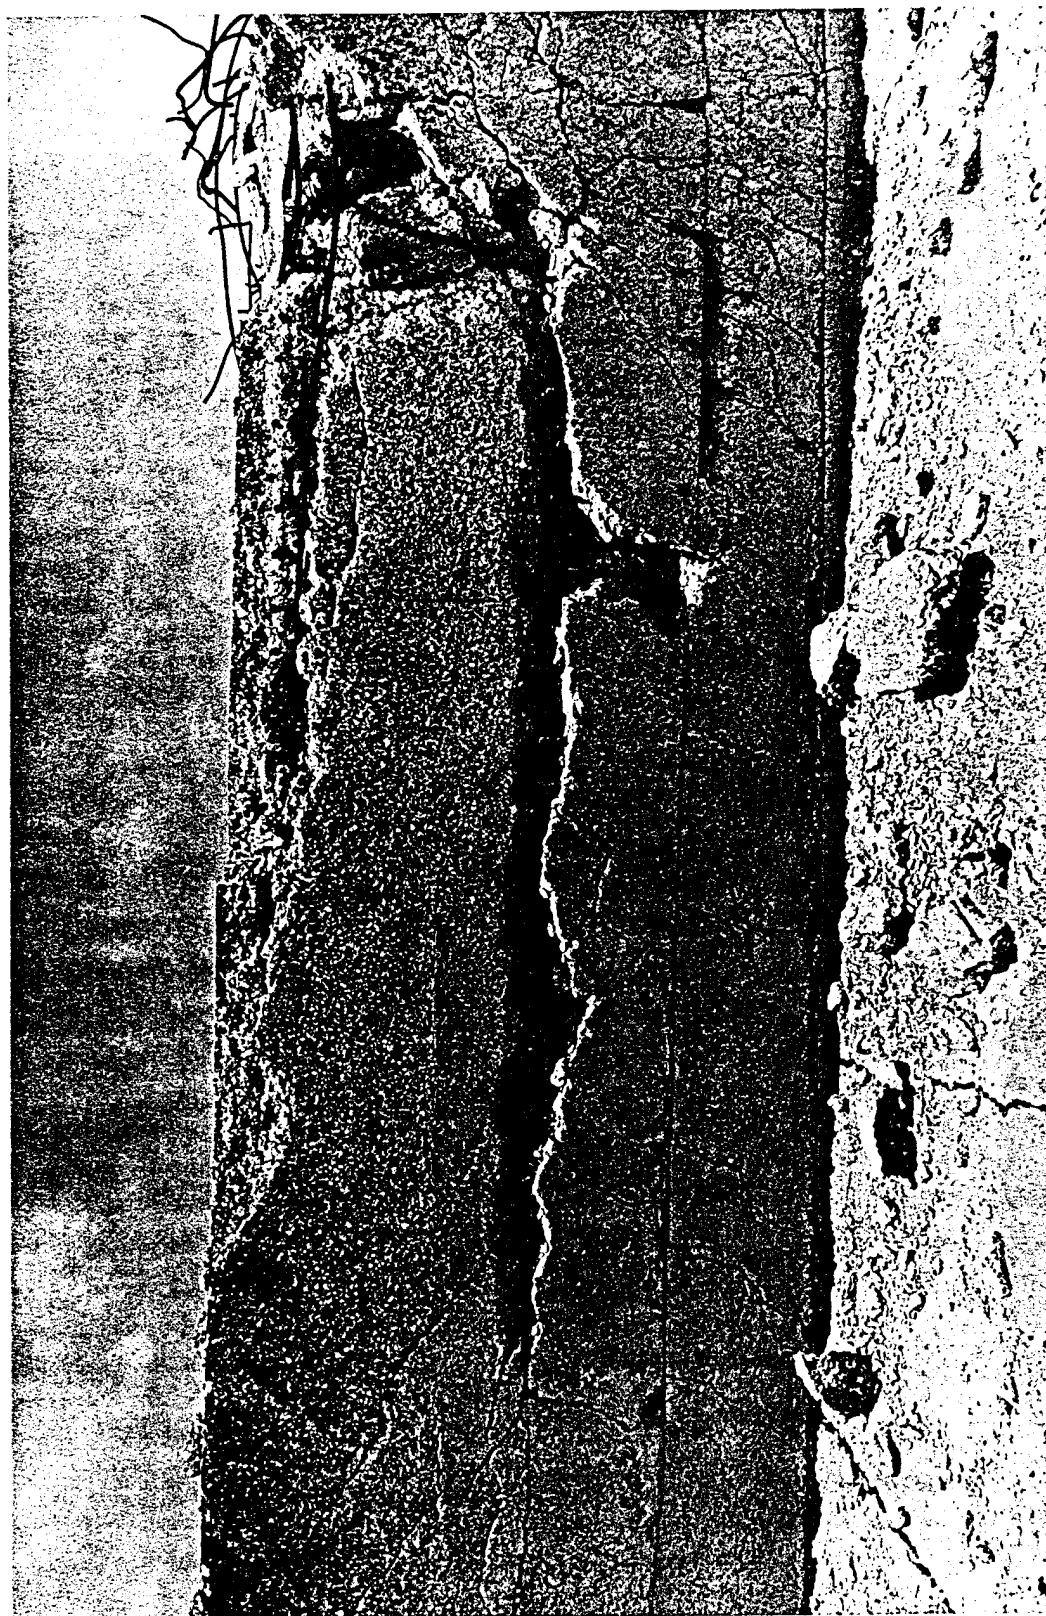
Fig. L.25 Center Section of Left Side Wall, Structure 3.2.1a

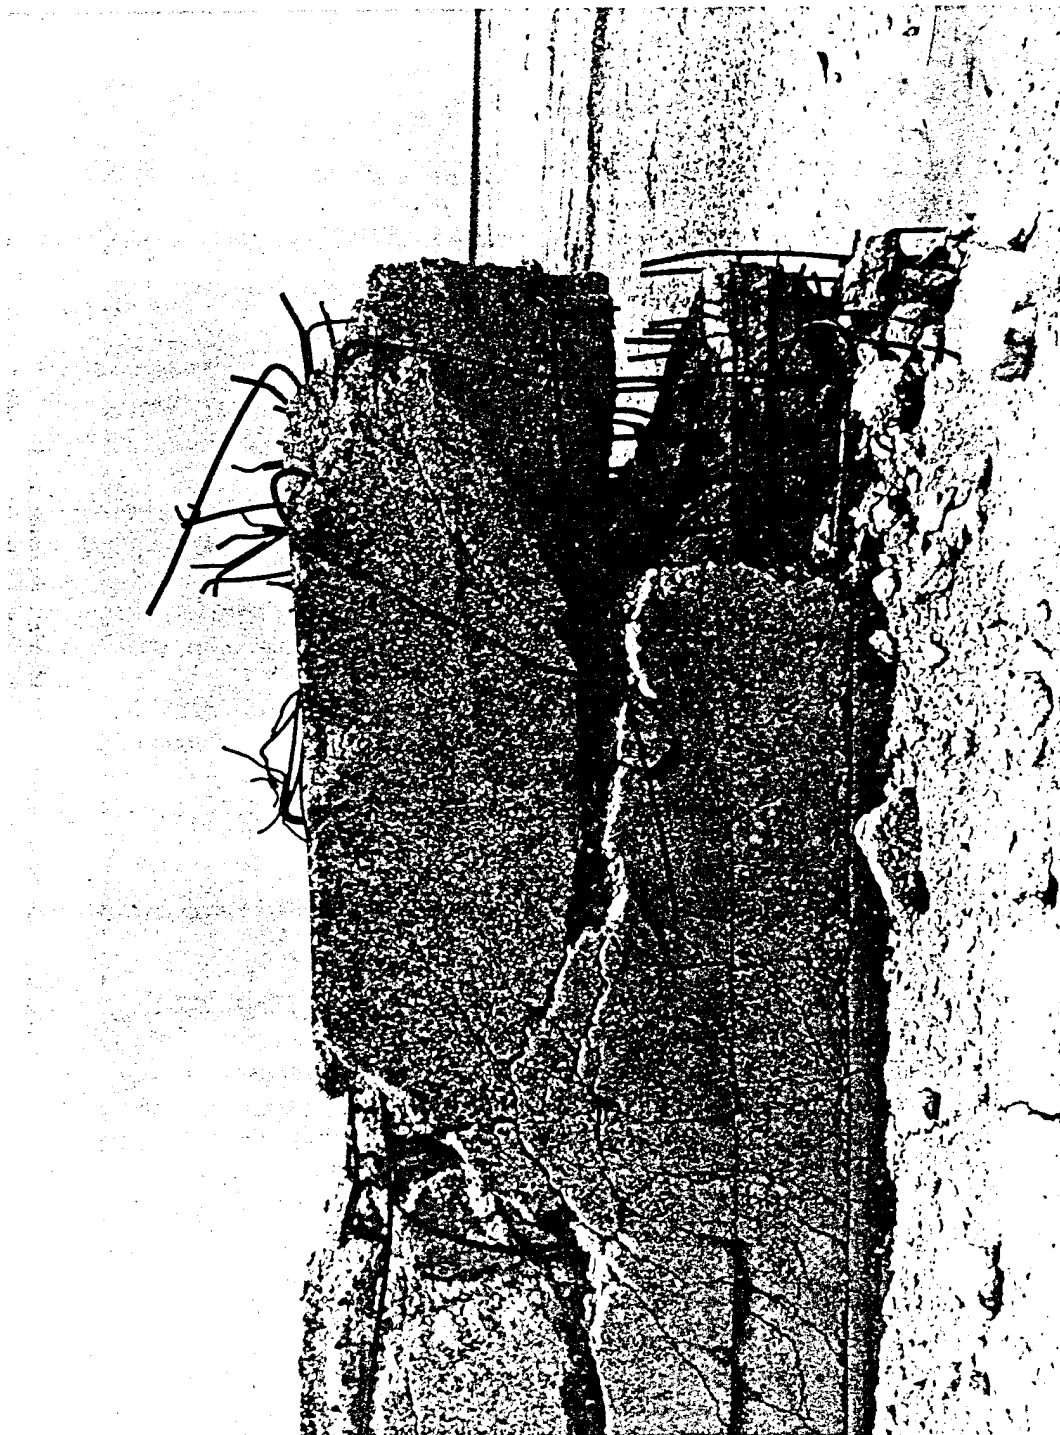
Fig. L.26 Right Half of Left Side Wall, Structure 3.2.1a

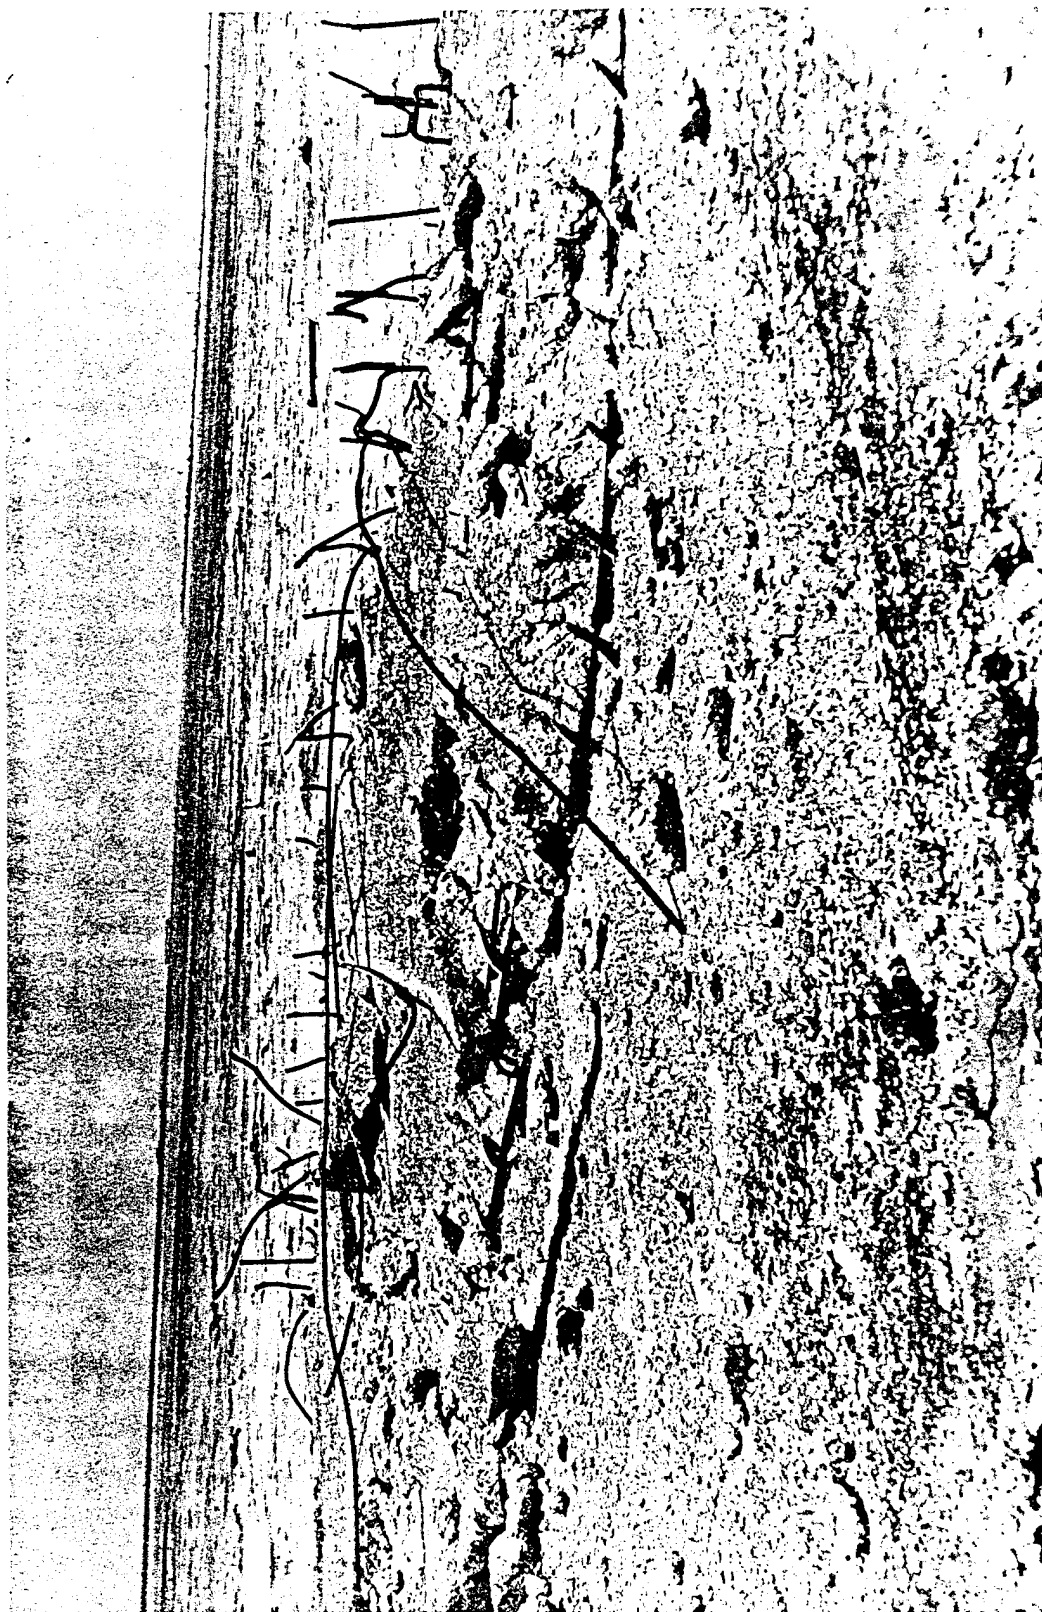
Fig. L.27 Front Edge of Roof from Left Rear Showing Top of Shear Plane, Structure 3.2.1a

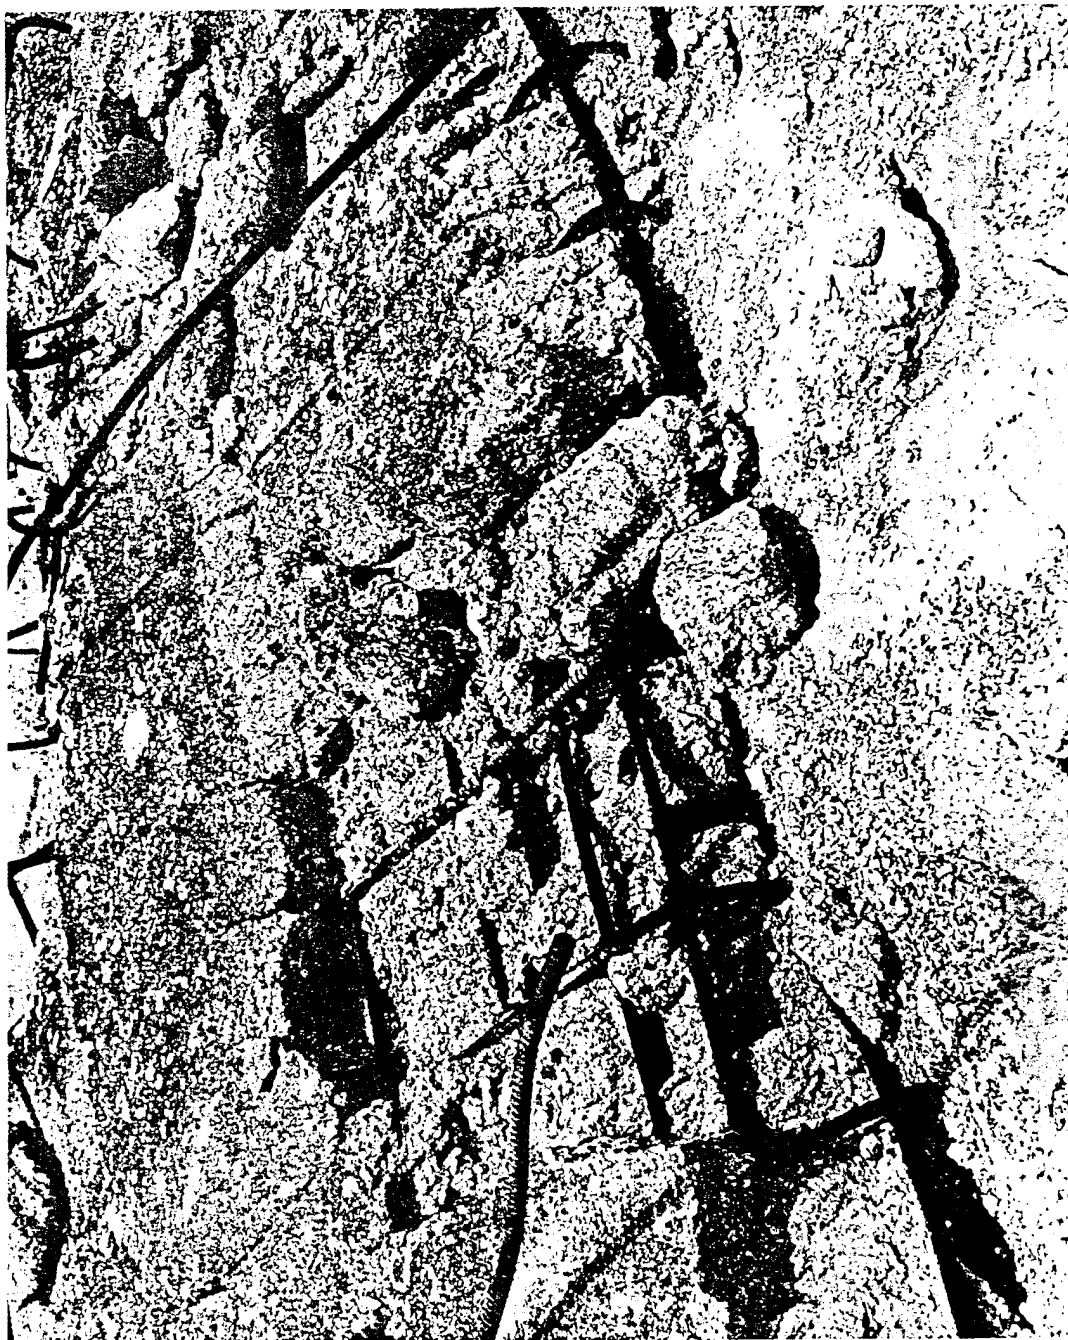
Fig. L.28 Close-up of Shear Plane 8 ft Back from Front Edge, Structure 3.2.1a

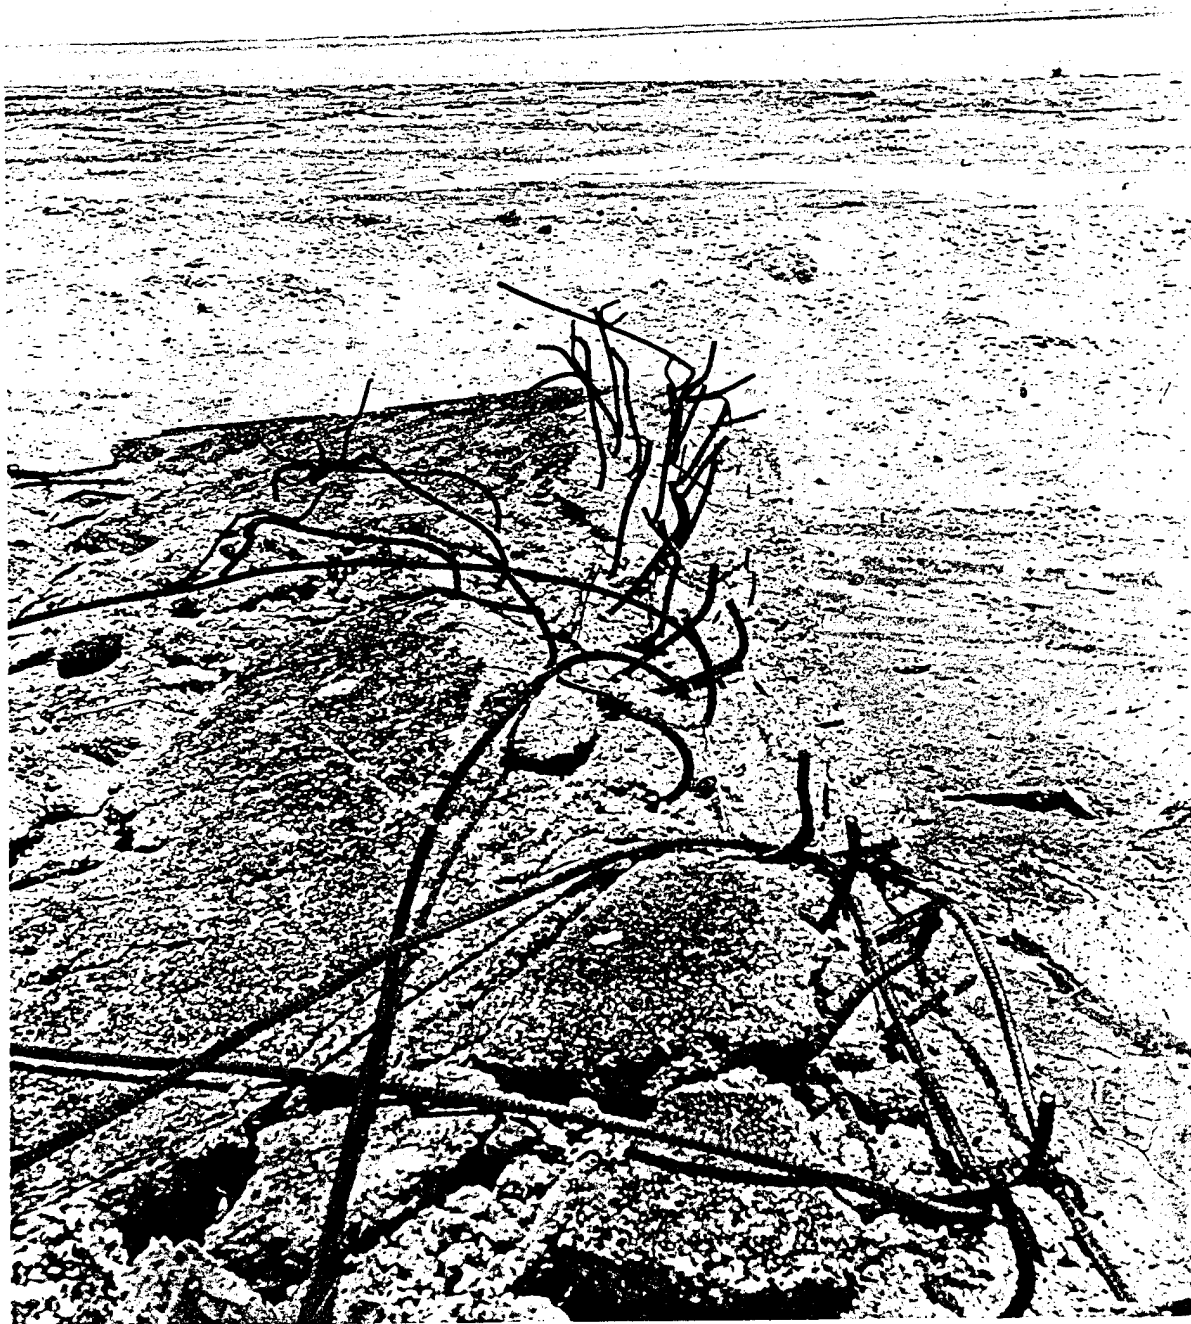
Fig. L.29 Exposed Steel along Top Front Corner, Structure 3.2.1a

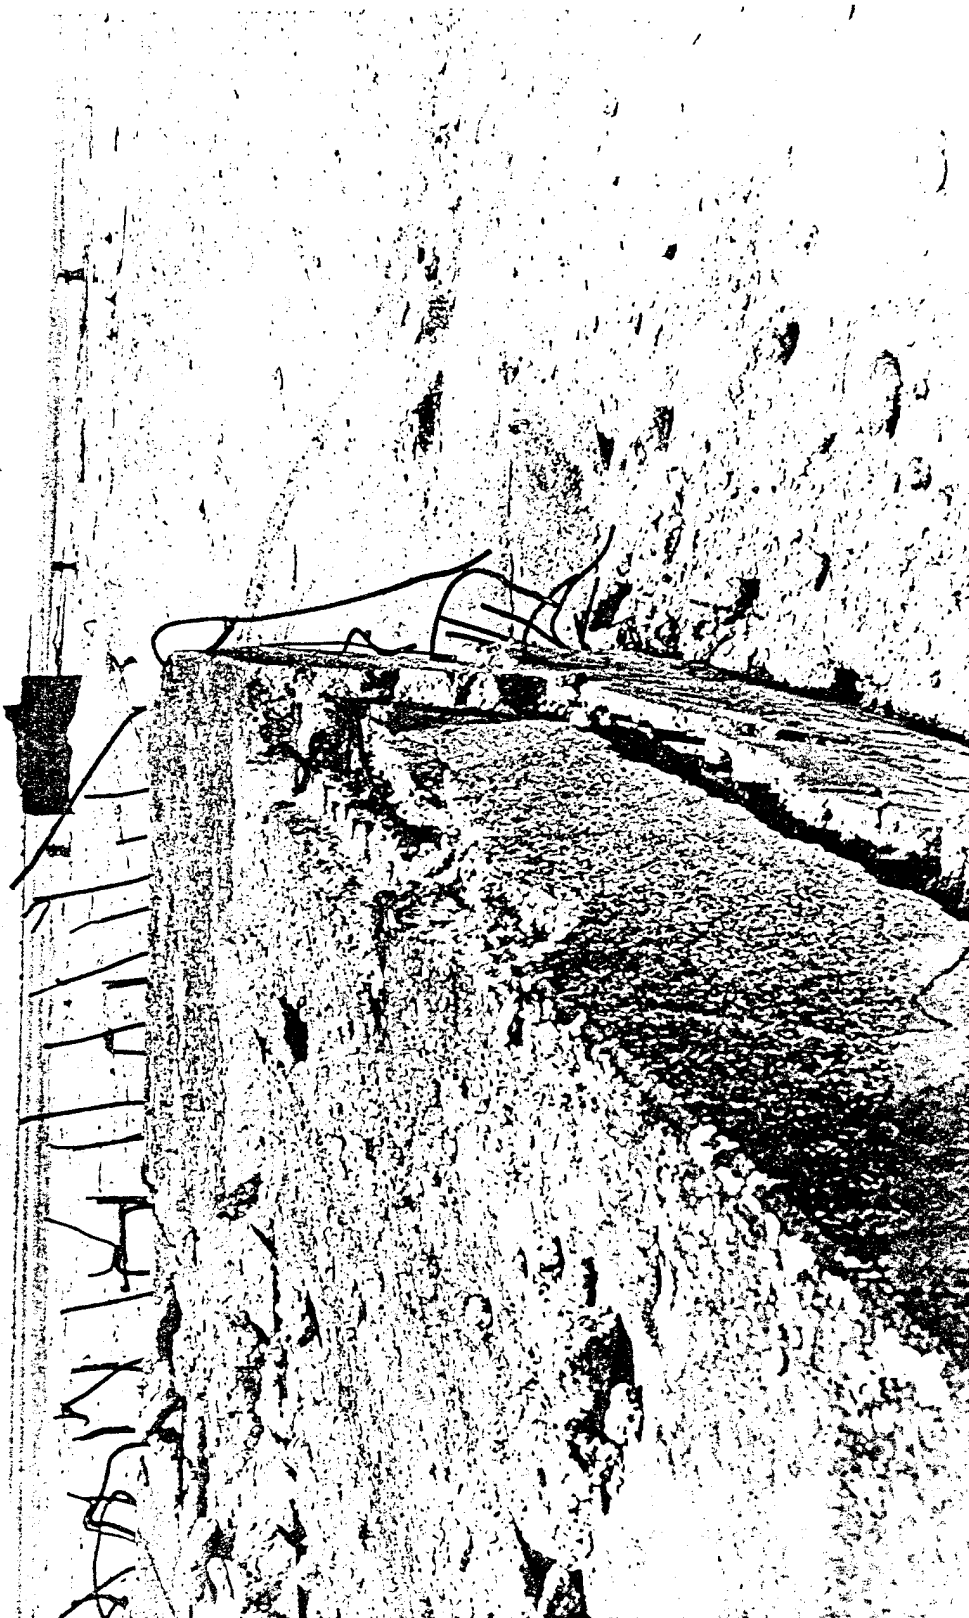
Fig. L.30 Left Front Corner from Rear, Structure 3.2.1a. Note separation along edge of slab.
